DAIKIN INDUSTRIES, LTD. AFTER SALES SERVICE DIV.

SM – 21

CONTENTS

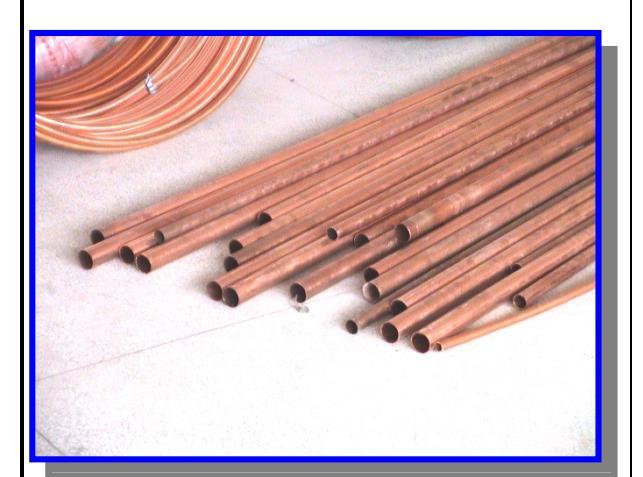
1-2) Problem of storage of copper tubes!!

Piping materials are casually kept on the floor at a construction site. No seal plugs are placed on the ends of the tubes.

①No seal plugs are found on the ends of tubes.②The tubes are directly laid on the floor.

- ©Since moisture, dust, sand, and rubbish could go into the tubes, these circulate in a refrigerant circuit during operation of the unit and are blocked at an expansion valve or a capillary tube, and also at a filter in the worst case, resulting in insufficient capacity and finally a malfunction will occur.
- ⁽²⁾Using the tube deformed on which a worker stepped may cause an insufficient capacity of the unit or an offensive noise due to the refrigerant passes through the narrow section of the tube.

The best way is to store the tubes on a stand to prevent them from rolling. Put caps on both tube ends or wrap the ends with vinyl tape securely so that moisture, dust, rubbish and sand will not enter the tubes.

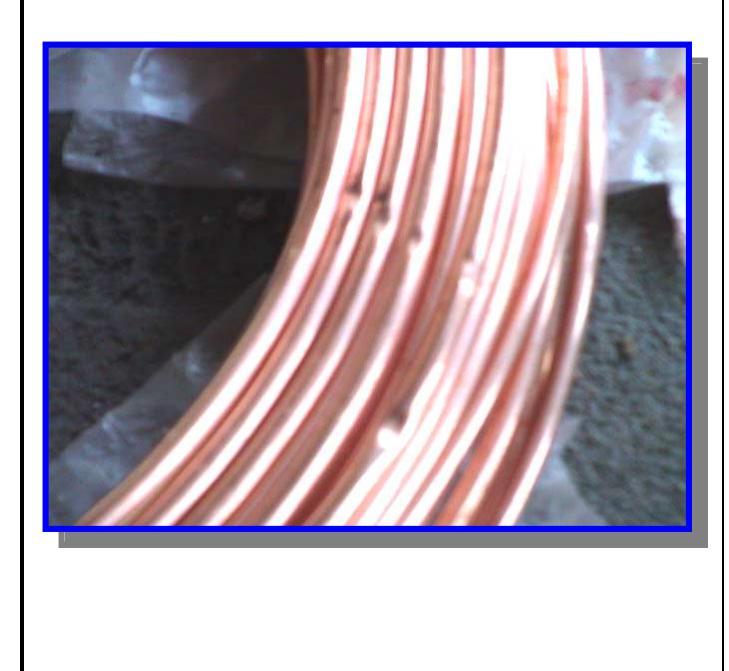
1-3) Trouble caused by using thin wall tubes!!

An actual example of too thin wall tubes

Even little stress can damage and deform the tube walls due to weakness.

These tubes have less thickness in the wall than Daikin's recommended tubes.

①Accordingly high pressure during operation can cause the tubes to deform and crack resulting in gas leakage.

⁽²⁾As you see in the photo, since the tubes can easily hollow, the unit will operate with insufficient capacity.

Also, sometimes, as the refrigerant passes through the narrow area, an offensive noise can be heard.

Be sure to use copper tubes mentioned below.

Tube OD [mm]	Wall thickness of copper tubes						
	specified by DAIKIN[mm]						
6.35	0.8						
9.52	0.8						
12.7	0.8						
15.9	1.0						
19.1	1.0						
22.2	1.2						
1

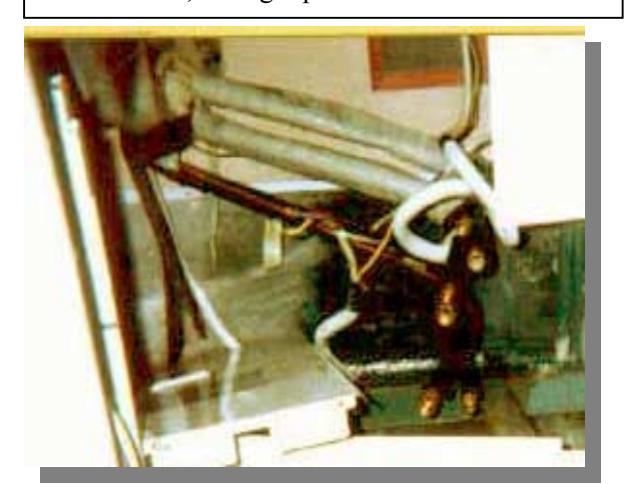
1-4) Trouble that the tubes are left without proper care!!

An actual example of tubes which are stored without proper care after the connected component was removed, during repaire of the unit.

The tubes are left without proper care after the component was removed.

Moisture caused by rainwater or condensation, dust, rubbish and sand enter the tubes resulting in a block in the expansion valve, capillary tube or filter. This may cause a compressor failure or insufficient operation.

When tubes are removed and stored even for a short time, be sure to provide care on the end of the tubes with blind cap. If blind caps are not available, it is recommended to wrap the tube ends including flare nut with vinyl tapes. (see the left picture)

* Pay attention so that dust, rubbish, or moisture on the tubes or flare will not enter the tubes when making care them.

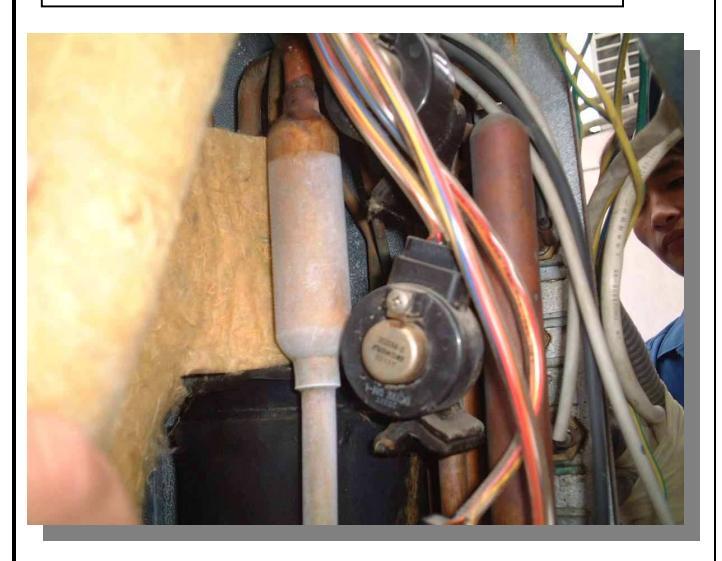
Actual example of frosting caused by filter choke

In the outdoor unit, icing is sometimes found on the filter. This shows a typical filer choking phenomenon in which the upstream side is hot while the downstream side is frozen.

During the piping work, moisture, dust, rubbish or sand entered the circuit.

- The refrigerant in the downstream side is shorted and pressure decreases to reduce the capacity due to the filter choke.
- ②Extreme super heated operation could take place if such an abnormal operation continues. Censequently, the safety switch will actuate to stop the operation.
- This will finally result in compressor failure.

- •Be careful that moisture will not remain in tubes.
- a. Perfect care for tubing
- b. Remove moisture in tubes by the flashing work
- c. Pay attention to the potential of moisture mixing into tubes when piping work is done on rainy day (especially in outdoor work).
- d. Be sure to perform vacuum drying process before the test run.

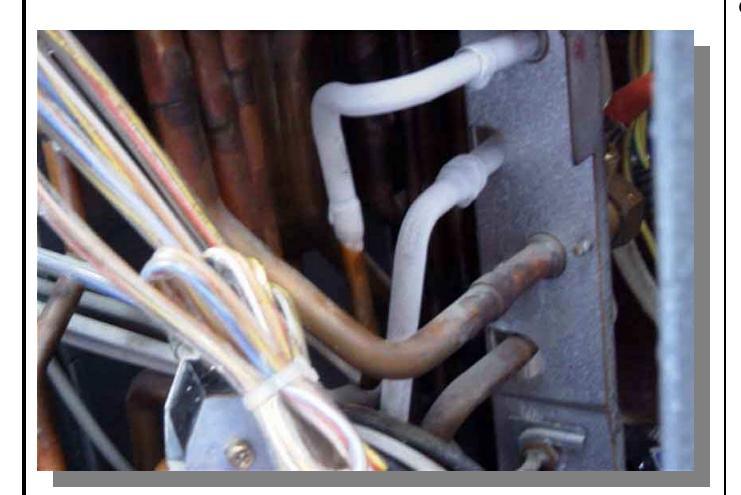
Frozen choke has occured in the distributor on the outdoor unit heat exchanger.

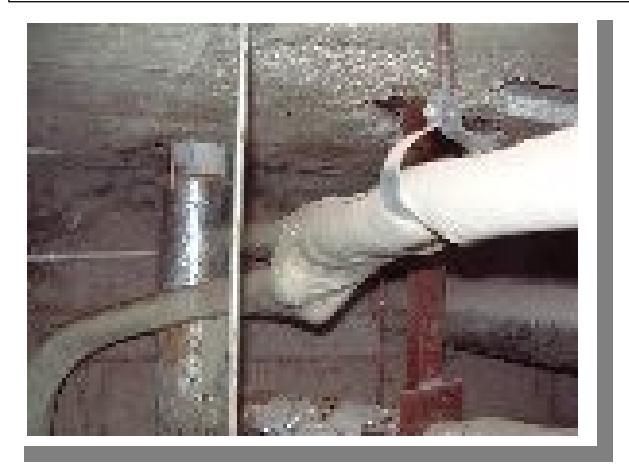
1-7) Trouble due to REFNET JOINT connection fault!!

An actual example in which the Refnet Joint is not positioned correctly as shown in the picture below.

Fault positioning of Refnet Joint in terms of direction . (Gravity influences to create drifting).

①Excessive noise by refrigerant passing will arise.②Capacity shortage will occur which is caused by refrigerant drift.

When the Refnet Joint is installed, be sure to install it in correct direction within the specified range as illustrated below.

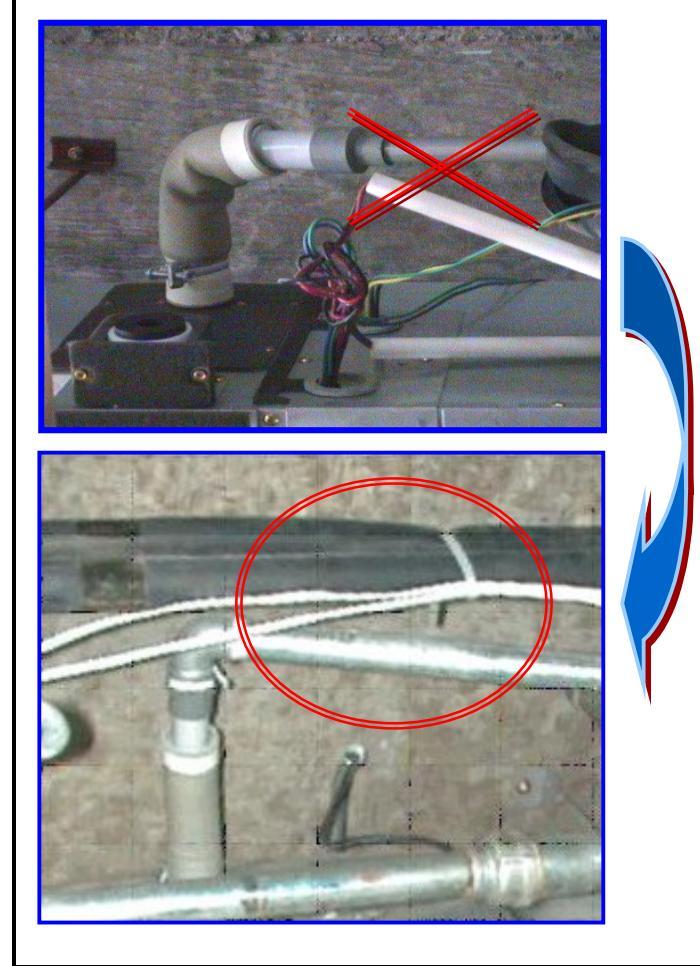
2-1) Problem caused by faulty selection of drain pipe size!!

A smaller sized pipe is used than the pipe size specified by DAIKIN.

"VP25" (inside diameter) is used in Japan while "PVC25" (outside diameter) is normally used in China.

This is likely to cause incorrect selection of pipe size.

As the size is too small to drain sufficiently:

The unit will display a malfunction and then stop, and it will become impossible to operate.

²Water leak will occur.

Refer to the table below and use the pipe size specified.

Since the pipe size suitable for every type of model is listed in the DAIKIN Engineering Data books, make sure the correct pipe size is choosen prior to installation.

Pay particular attention for reading the outside diameter and the inside diameter correctly. Be sure to use the size specified.

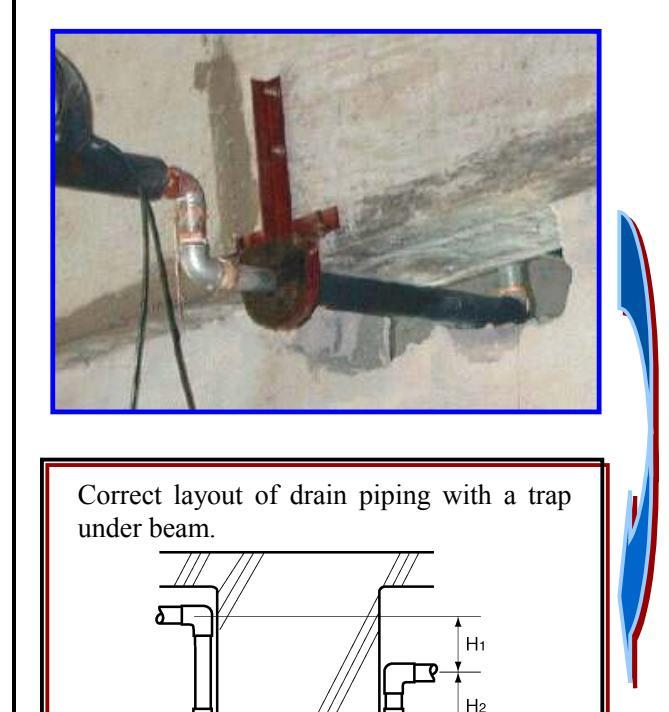
2-3) Problem of choke inside a drain pipe!!

A drain trap is provided(a bend as shown left).

Due to water remaining in the bend and dust or rubbish accumulating inside the drain piping, the pipe is blocked and water will not flow out, and---

^①The unit will display malfunction and stop, and then will become impossible to operate.

②Water leak will occur.

It is a basic policy not to provide a trap.

- ①If a trap is to be installed, it should be made so as to be able to clean up inside the drain pipe.
- Take notice that H₁ should have at least 50mm or more in order to cope with reverse flow caused by negative pressure generated in the indoor unit.

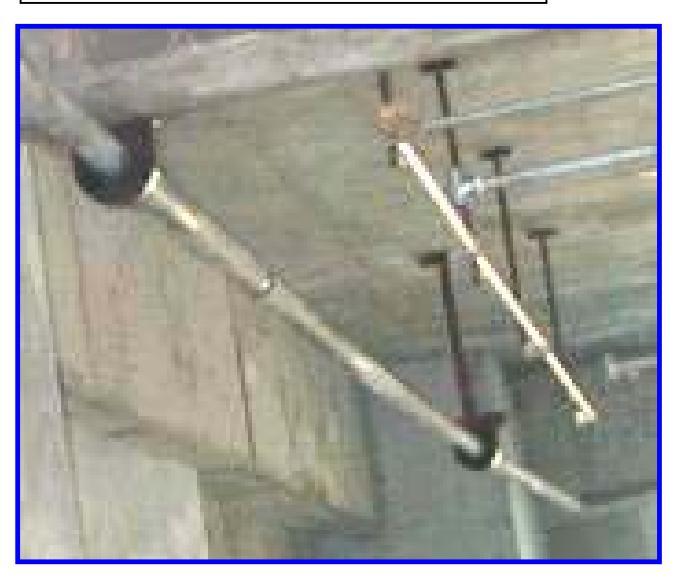
2-4) Problem of reverse gradient of drain piping!!

An actual example of the bend with an excessive long pitch of the suspension.

Excessive long pitch of the suspension for drain piping

It becomes impossible for the drain to flow out due to the reverse gradient with the bent at the center as shown in the picture left.

^①The unit will display malfunction and stop, and then will become impossible to operate.

^②Water leakage will occur.

The pitch of suspension must be set at an interval of $0.8 \sim 1.0$ m and pay attention so that piping will not bend (take 1/100 or more for the gradient!!)

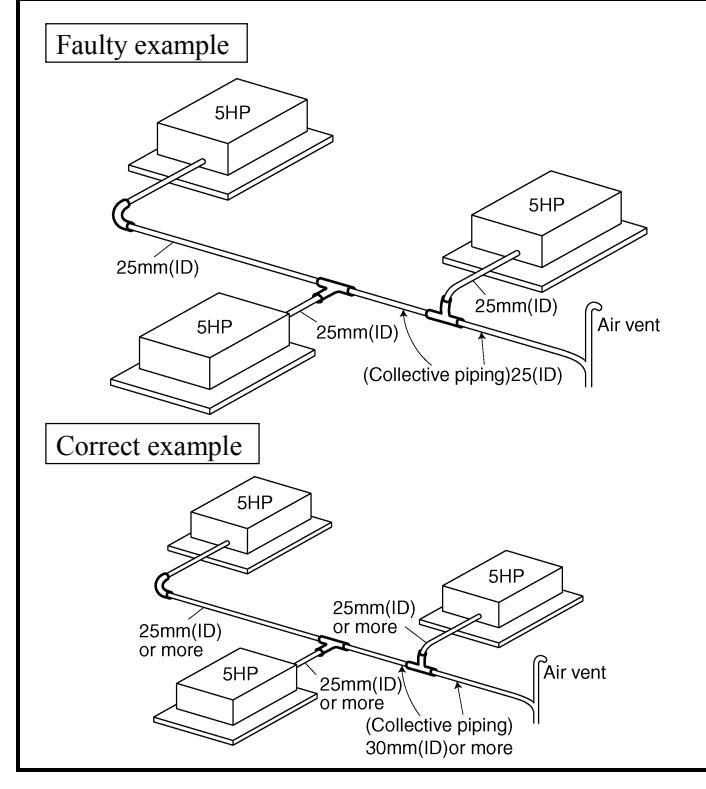
2-5) Trouble by faulty selection of piping size for collective drain piping!!

Smaller sized piping is used at the collective part.

As the water flow decreases at the collective part, a protection device actuates to stop the operation.

- ①At least 30mm (ID) or more should be used for collective piping.
- ⁽²⁾Check the table below and make sure the correct size pipe is selected and used.

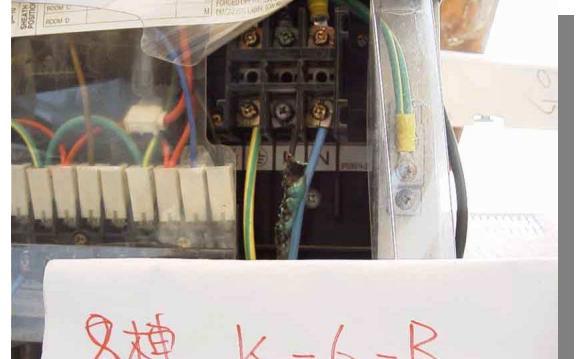
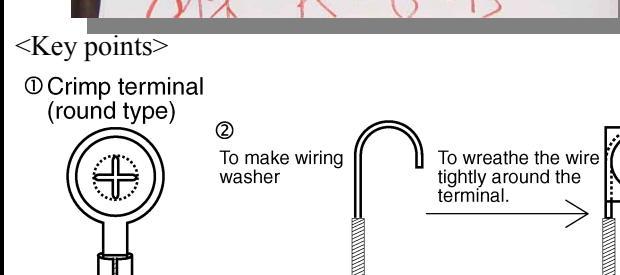
3-2) Problem of seizure on power supply wiring!! (2)

The power supply wiring has been burnt out due to poor tightening of the wire and subsequent continuous over-current.

Because it was tightened over the insulation part, the screw was loosened.

- ^①The safety device will actuate to stop the unit due to the poor contact of the wiring.
- ②In the worst case, the over-current keeps flowing and results in a seizure.

- OFix the wire securely using a crimp terminal (round type).
- ⁽²⁾If it is not possible to use a crimp terminal, make the tip of wiring to a round shape and put it behind a washer of the terminal, securely tightening.
